Woodcote Parish Council

18 July 2025

# Safety Inspection Report

## Annual Inspection

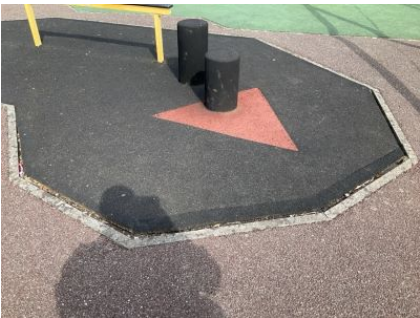
Shrinkage / separation of the surface. This may give a trip hazard.

Repair.

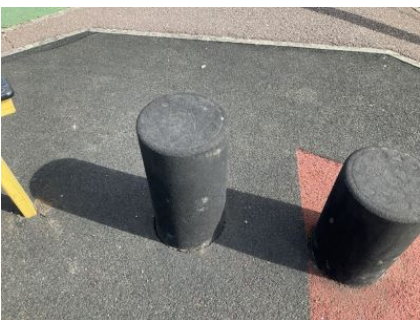
Loose in ground.

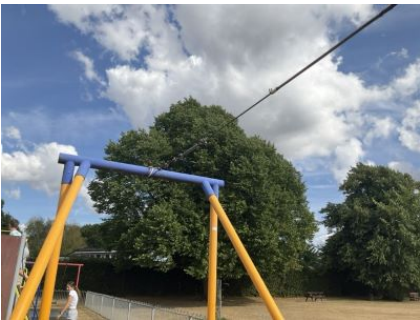
Cables have been known to fail under load due to wear and corrosion. This is generally where the cable enters into a tube, top bar, sleeve or similar, where the wire is in contact and wears and frays over time, but can happen anywhere on the cable. It is important to inspect any hidden parts at least annually. Damaged cables require replacement. This cannot be determined during an annual inspection, and is excluded from our inspection. This can lead to a high risk if no action is taken. Refer to the manufacturer's instructions to ensure the correct check is carried out.

Conduct an appropriate dismantling inspection according to the manufacturer's instructions, and at least annually. The trolley mechanism can be checked at the same time.

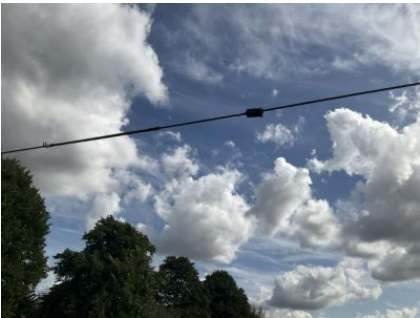
Item is damaged.

Replace.

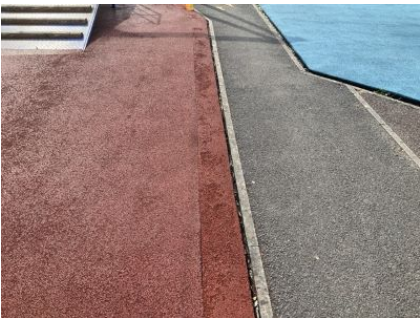
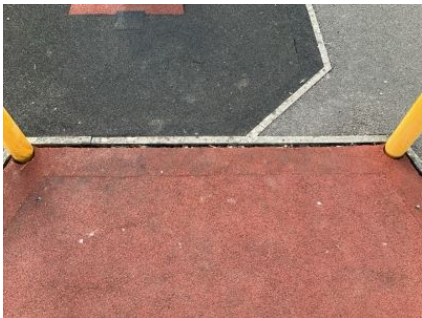
Shrinkage / separation of the surface. This may give a trip hazard.

Repair.

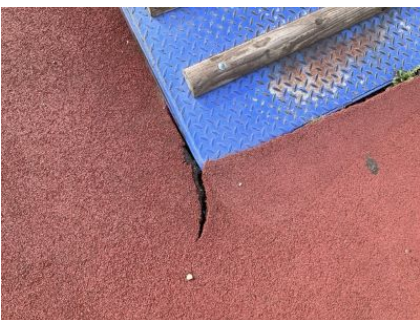
The surface is cracking.

Repair.

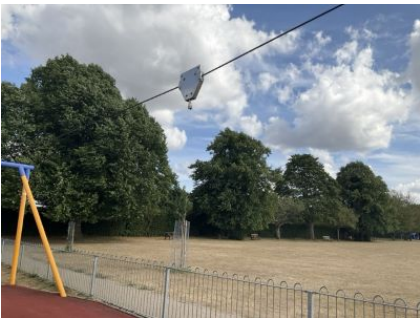
Missing item.

Replace.

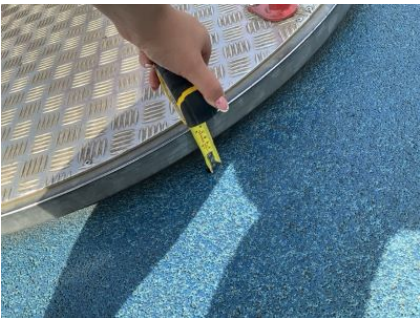
1. Shrinkage / separation of the surface. This may give a trip hazard.

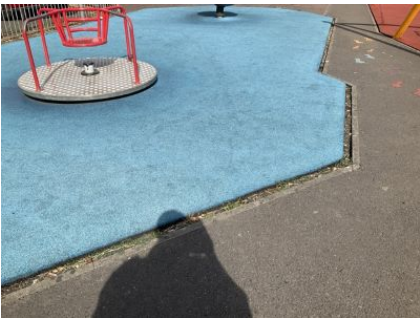
Shrinkage / separation of the surface. This may give a trip hazard.

Repair.

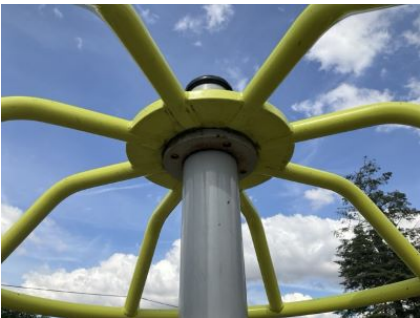
There is wear in the bearings.

Repair.

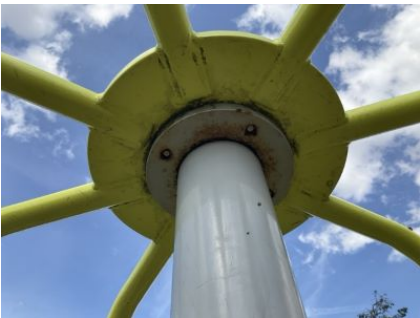
Item has corrosion.

Treat and repair.

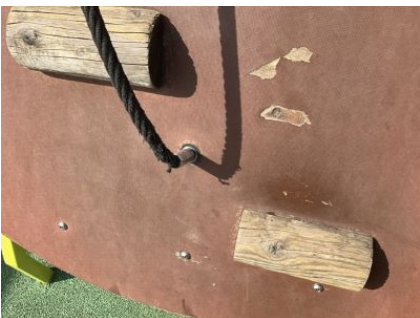
Fixtures loose or missing.

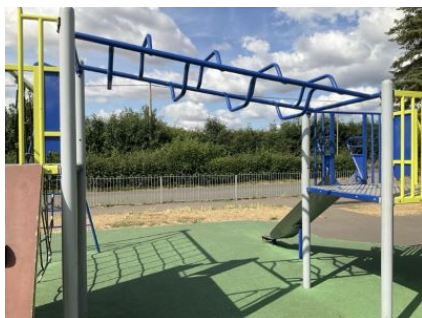
Overhead ladders and rings provide significant play value and benefits to children, and with it the risk of falling. Ensuring the surface remains in good condition will help to keep the correct balance between benefits and risk.

The protective surface under all bars and rings must be kept in good condition.

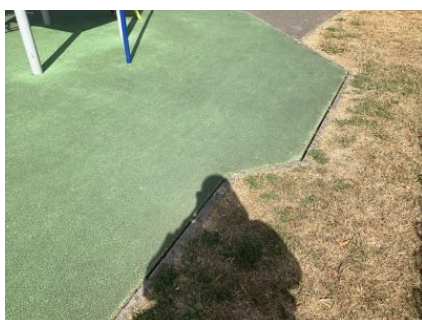
Shrinkage / separation of the surface. This may give a trip hazard.

Repair.

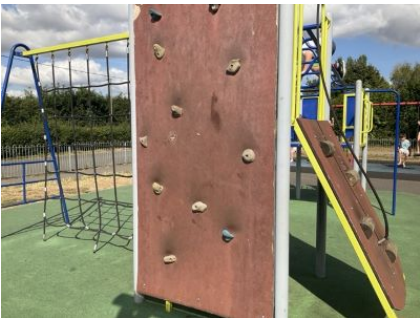
Bolt(s) loose.

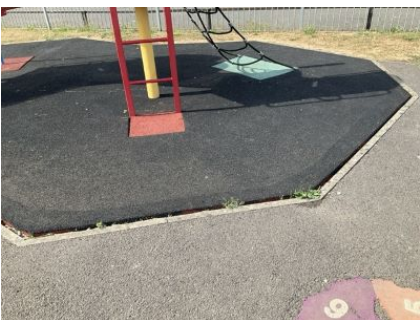
Shrinkage / separation of the surface. This may give a trip hazard.

Repair.

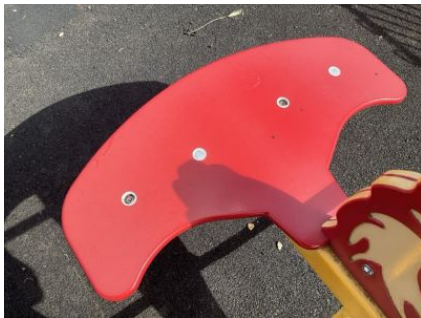
Bolt cap damaged.

Replace.

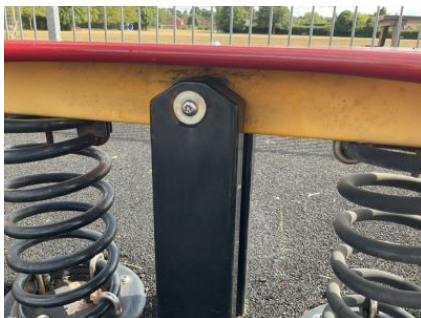
Bolt(s) loose.

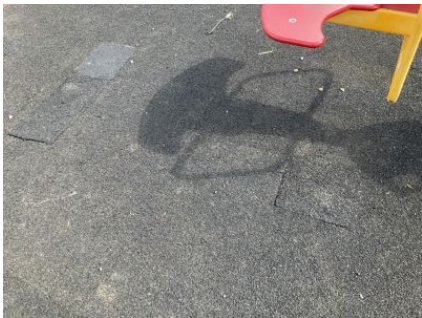
Surface needs repair.

Repair.

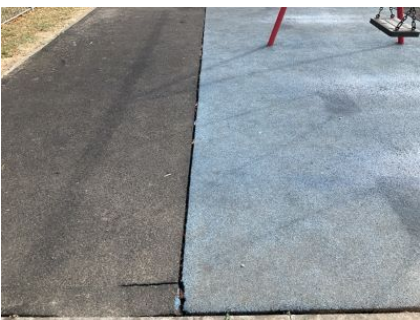
Shrinkage / separation of the surface. This may give a trip hazard.

Repair.

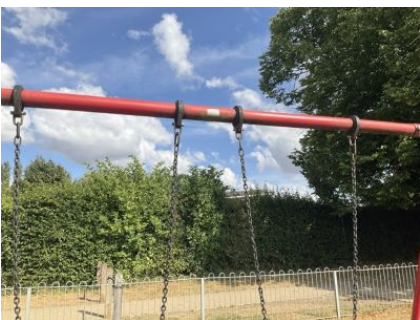
Item has corrosion.

Treat and repair.
