| Meeting | Woodcote Parish Council Meeting – 19 <sup>th</sup> November 2025 |

The.  
Survey.

Written instructions were received on 18<sup>th</sup> December 2021 from The clerk of Woodcote Parish Council, to carry out a Building inspection on Woodcote Parish Council Offices, Office Village Hall, Reading Road, Woodcote RG8 0QY

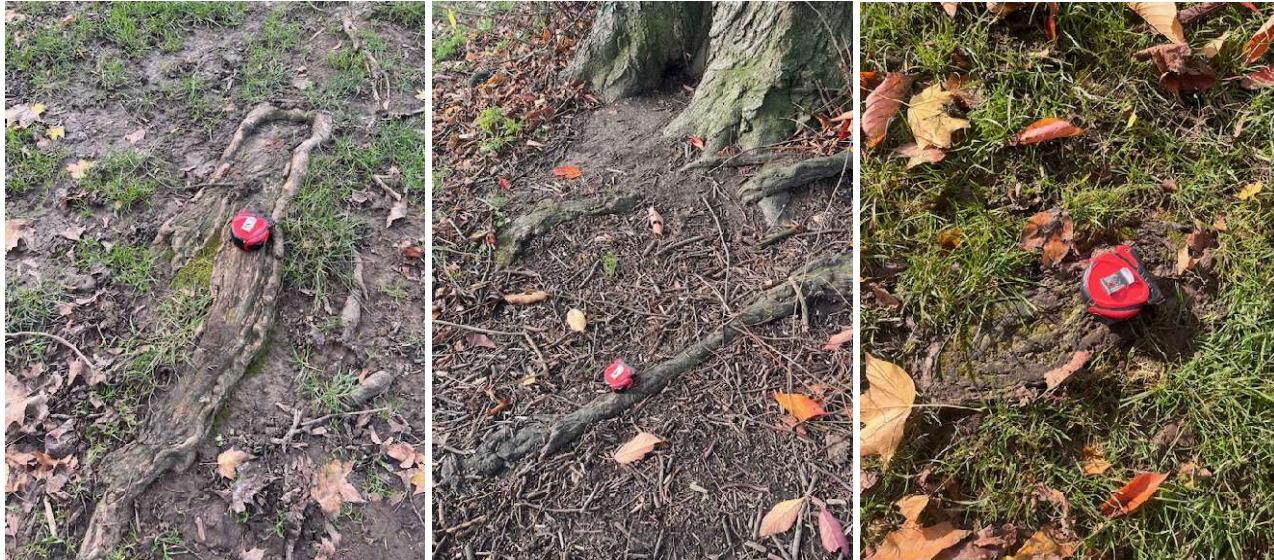
If the path must run between the school fence line and the trees, we will have to accept that all trees will suffer extensive damage. There are a lot of tree roots of radius 8 to 10cm already visible on the surface of the ground. The available space is 3.4m from tree trunk to fence line.

and have implications not just for tree health but also for user safety; depending on the drop created. I have attached a few photos of the tree roots visible with my measuring tape for scale. A majority of the trees - 10 very mature ones, one later planting and one or two saplings at the very end will have their roots impacted.

Images of some of the visible roots below.

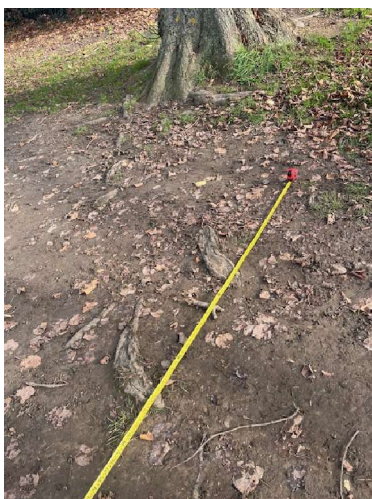
The below image shows the tape measurement of 3.2m from the goal line at the first tree (2m away from goal line + 1.2m proposed path width). The path will be cutting into ALL the roots seen as well as any within 50mm of the surface.

We will have to accept that we will damage at least one or two trees – it is hoped they will not be damaged enough to kill them.

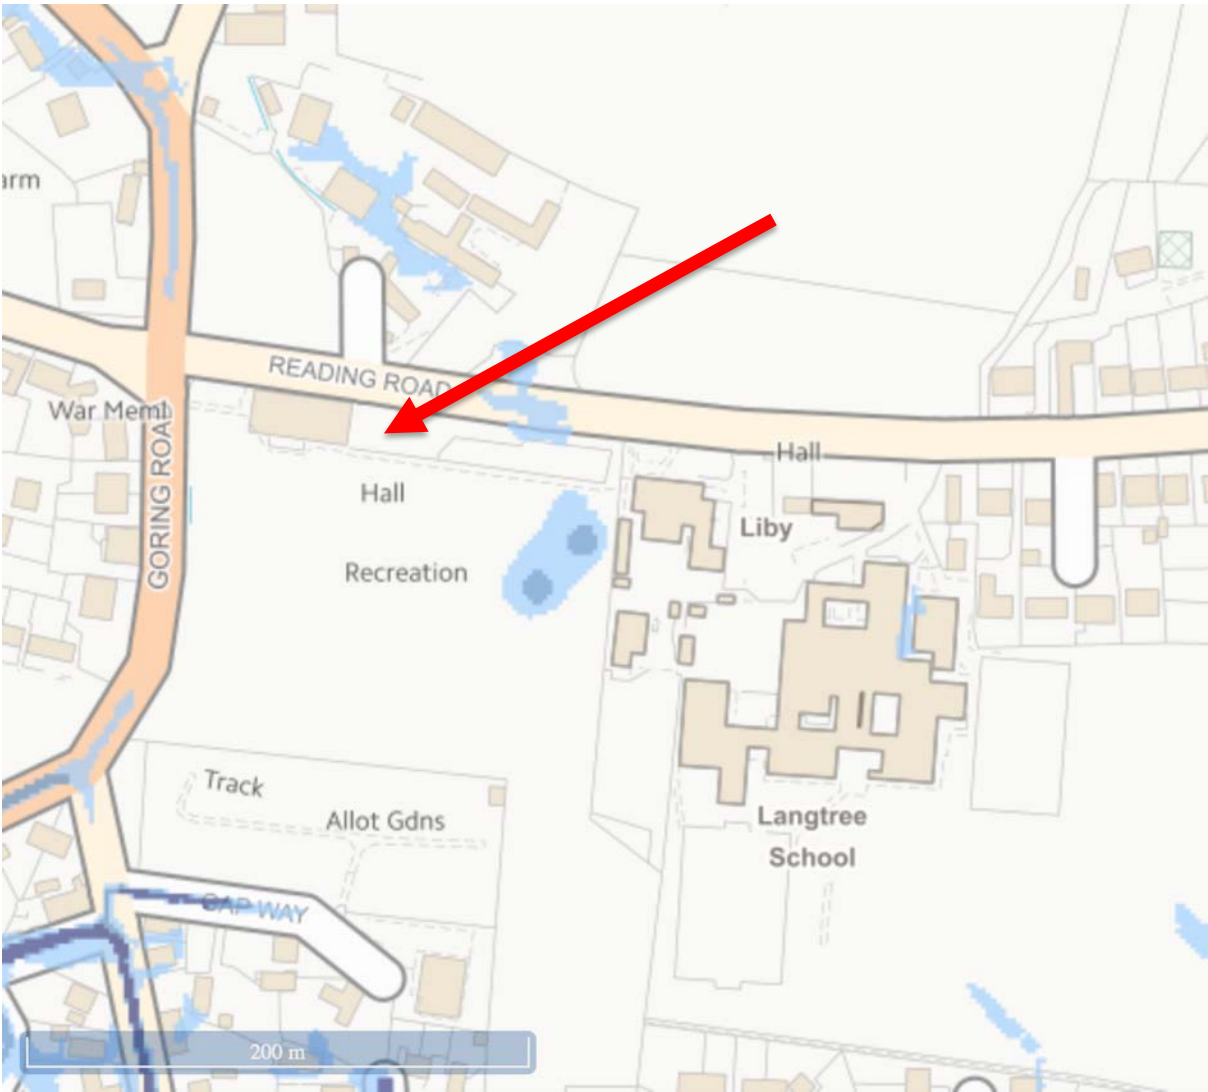
Figure 1 Showing no signs of significant surface water flooding following rainfall

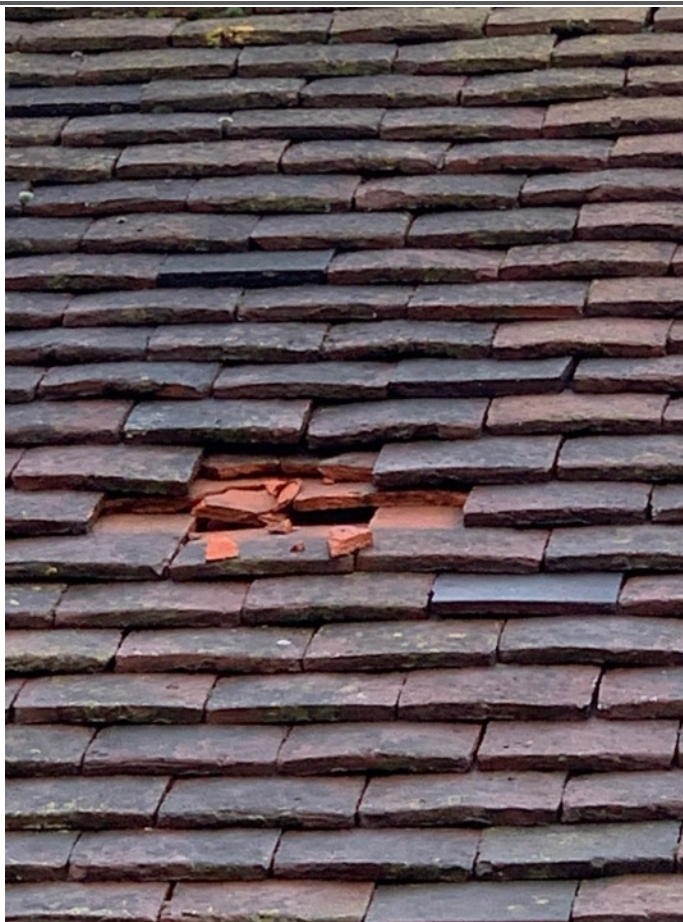
The Main clay tiles roof has 3. no holes from what we assume to be impact damage from falling cricket balls however equally the damage may have been caused by vandalism.

Photo showing direct impact damage of clay plain tile allowing for water ingress affecting the timber sarking board and rafters below.

The damaged tiles require replacement in the near future and urgent repairs are advised.

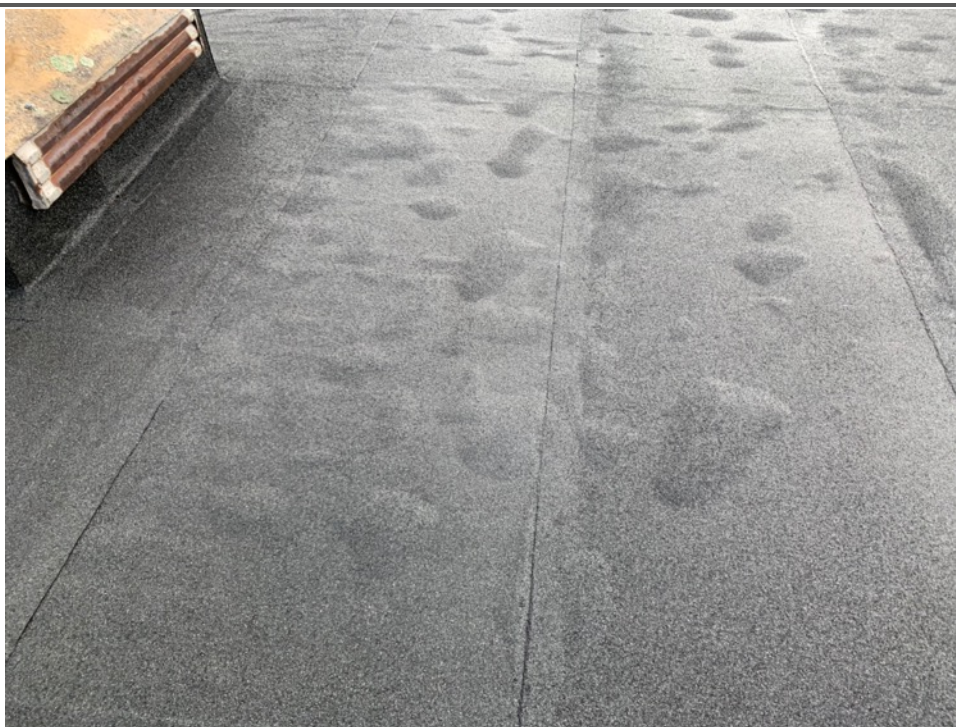
To the extended parts of the property, the roofing is a mineral felt overlaid on what we assume to be a flat roof ply board. This roofing is in particularly poor order and in need of replacement in the near future. This should take into account the internal rainwater downpipes which will require protection from leaves.

Photo Showing "bubbling" roofing felt .

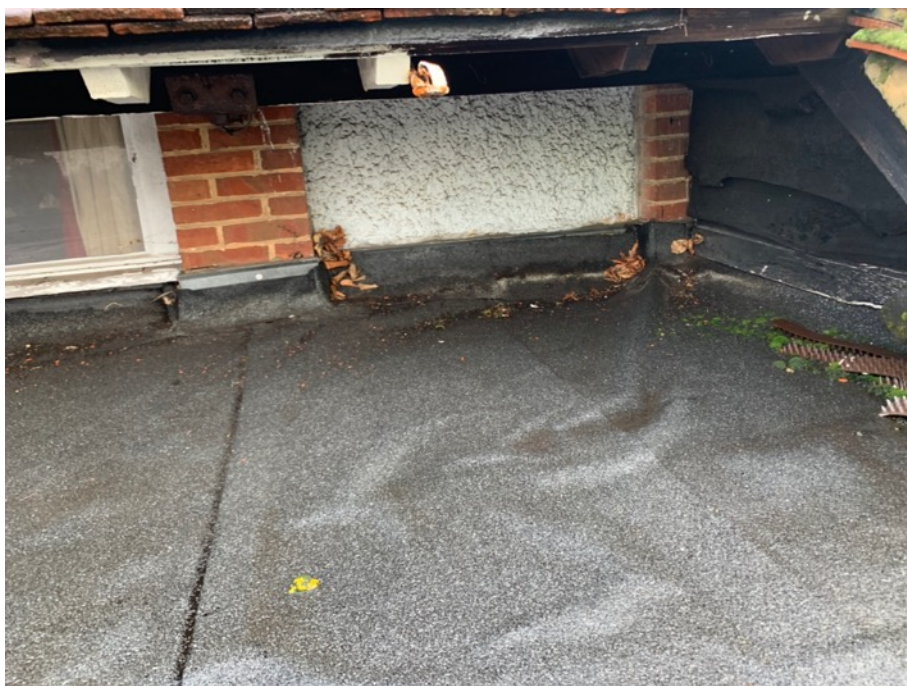
Photo Showing "bubbling" roofing felt .

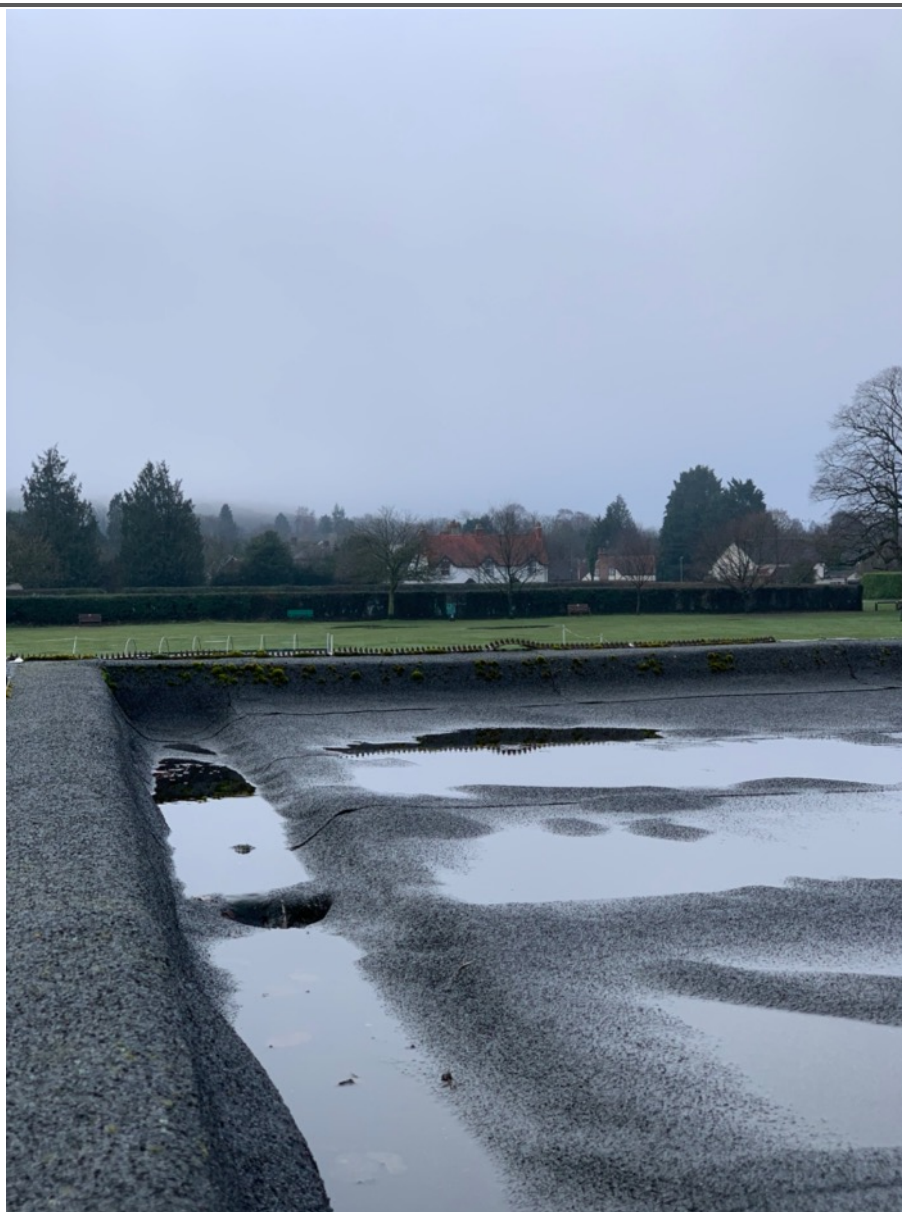
Photo showing ponding water around rainwater gulley indicating failure of water to flow away effectively

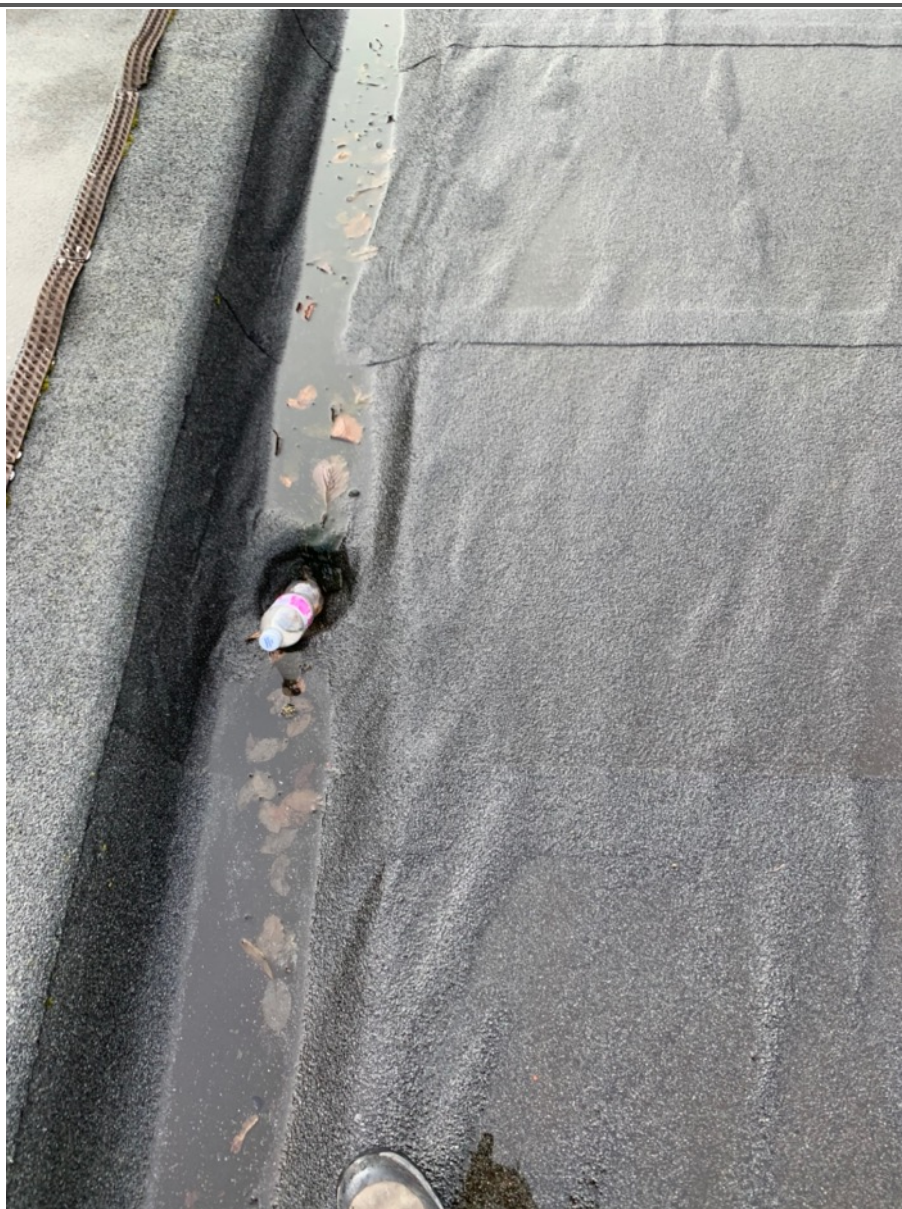
Photo of 1 of 3 bottles inserted into drainage gullies (thought vandalism)

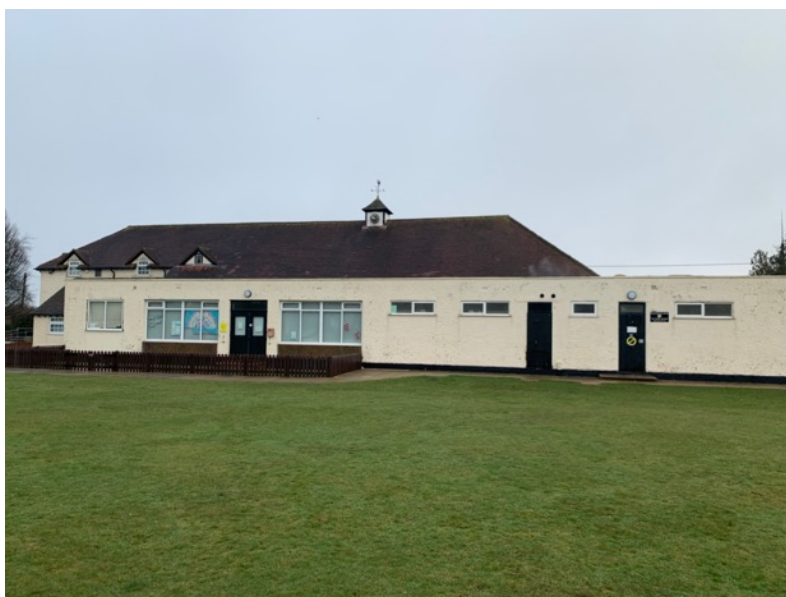
Where the property has been extended to the Pavilion/Woodcote Pre School, The render work is particularly porous and in poor repair. We have advised that along this elevation, the render be hacked back to solid surfaces prior to rerendering and redecoration.

Photo showing rear single storey elevation with render in generally poor repair

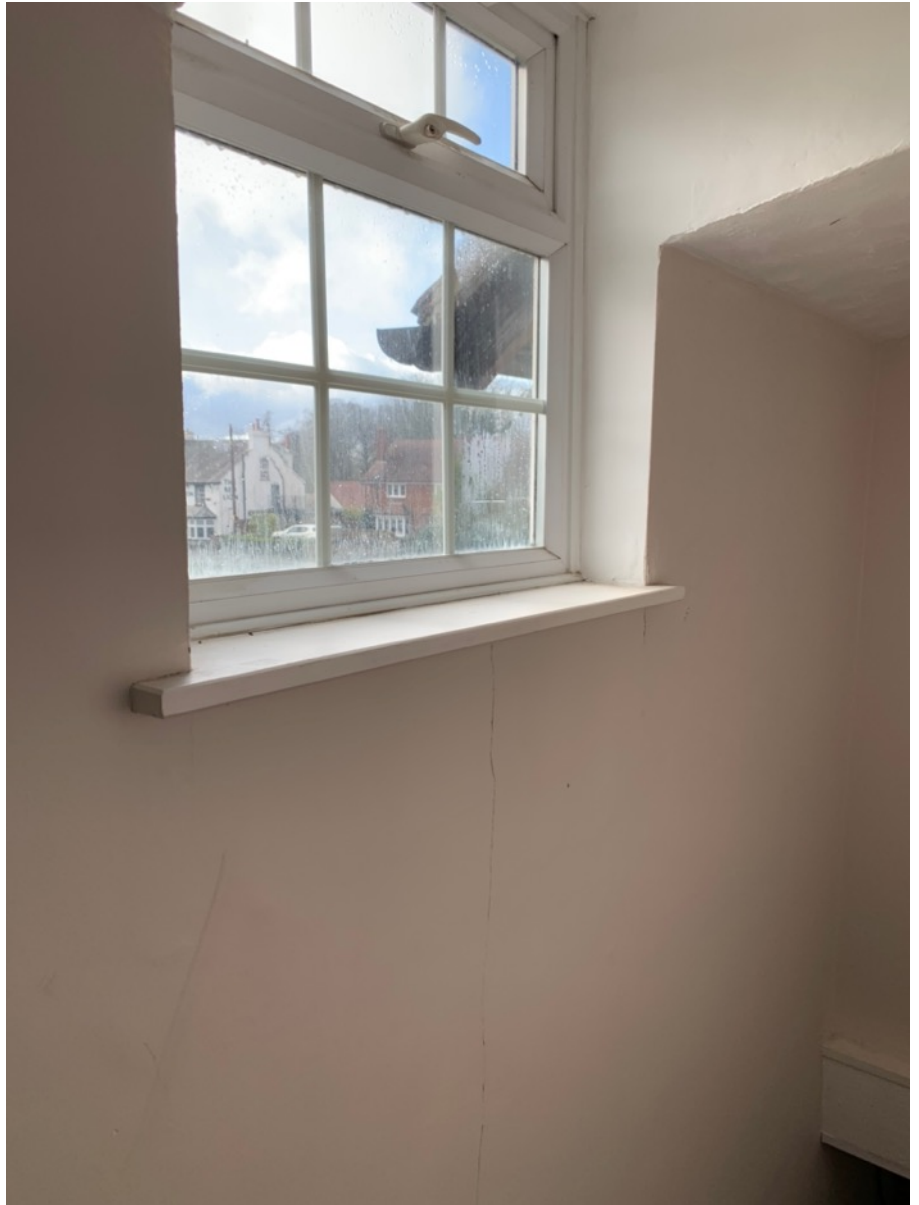
We are unaware as to the exact age of the window/door installation and would comment that double glazing often has a restricted life expectancy, sometimes around 10/15 years, dependent partly on initial construction standard of units. Over time, deterioration to the

glass edge seals often occurs, resulting in internal condensation arising between glass panes.

Photo showing condensation build up in glazed pane

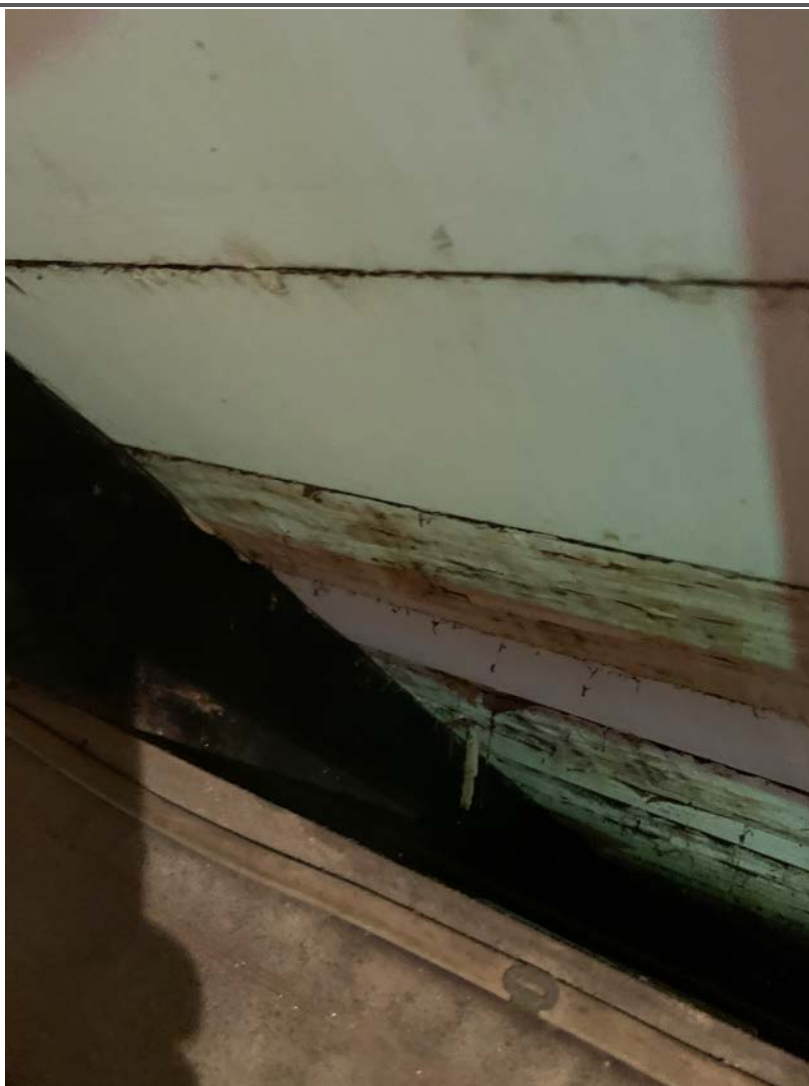
The roof void over the main hall shows some signs of moisture ingress in line with the damage shown externally.

Photo showing signs of water ingress to the rear roof slope thought in line with external hole in the roof.

It is our recommendation that the roof be repaired, sarking board be cut out and replaced and treatment of the rafters.

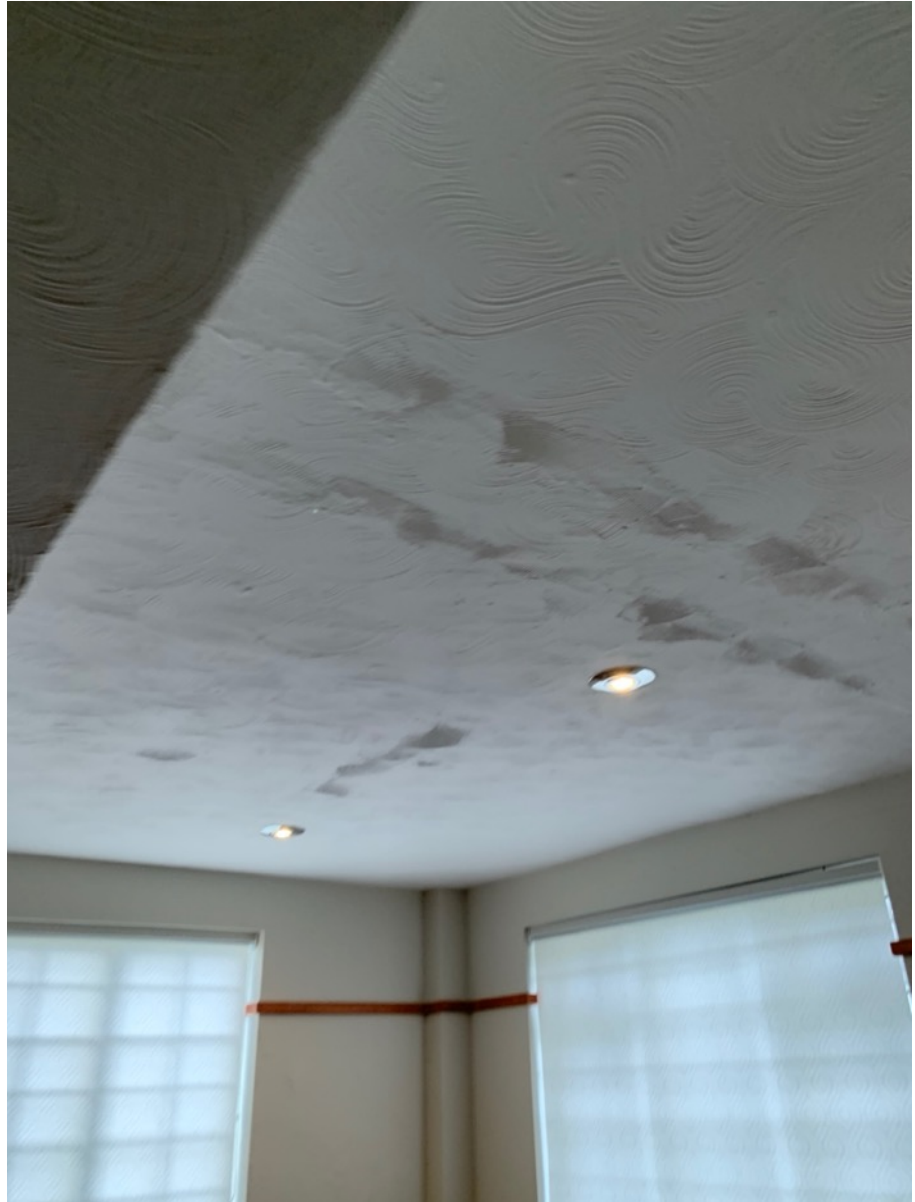
The textured ceiling to the right hand side appears to have suffered some historic water leak thought to have been from the roof above. This issue appear to have been rectified although the ceiling does require replastering and redecoration.
