# Woodcote Village Hall re-roofing works to flat roof sections

The.  
Survey.

Written instructions were received on 18<sup>th</sup> December 2021 from The clerk of Woodcote Parish Council, to carry out a Building inspection on Woodcote Parish Council Offices, Office Village Hall, Reading Road, Woodcote RG8 0QY

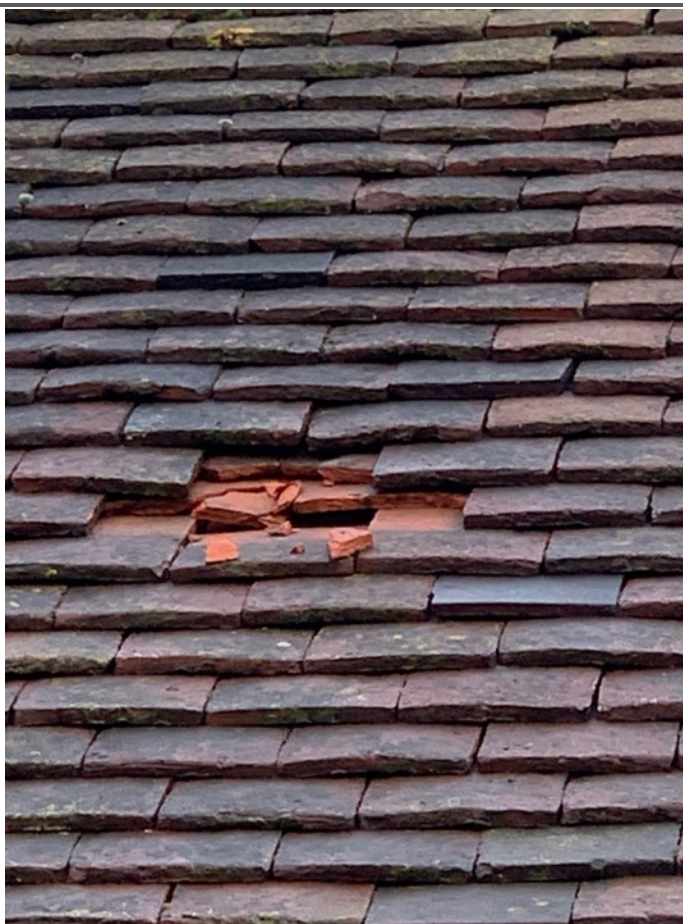
The Main clay tiles roof has 3. no holes from what we assume to be impact damage from falling cricket balls however equally the damage may have been caused by vandalism.

Photo showing direct impact damage of clay plain tile allowing for water ingress affecting the timber sarking board and rafters below.

The damaged tiles require replacement in the near future and urgent repairs are advised.

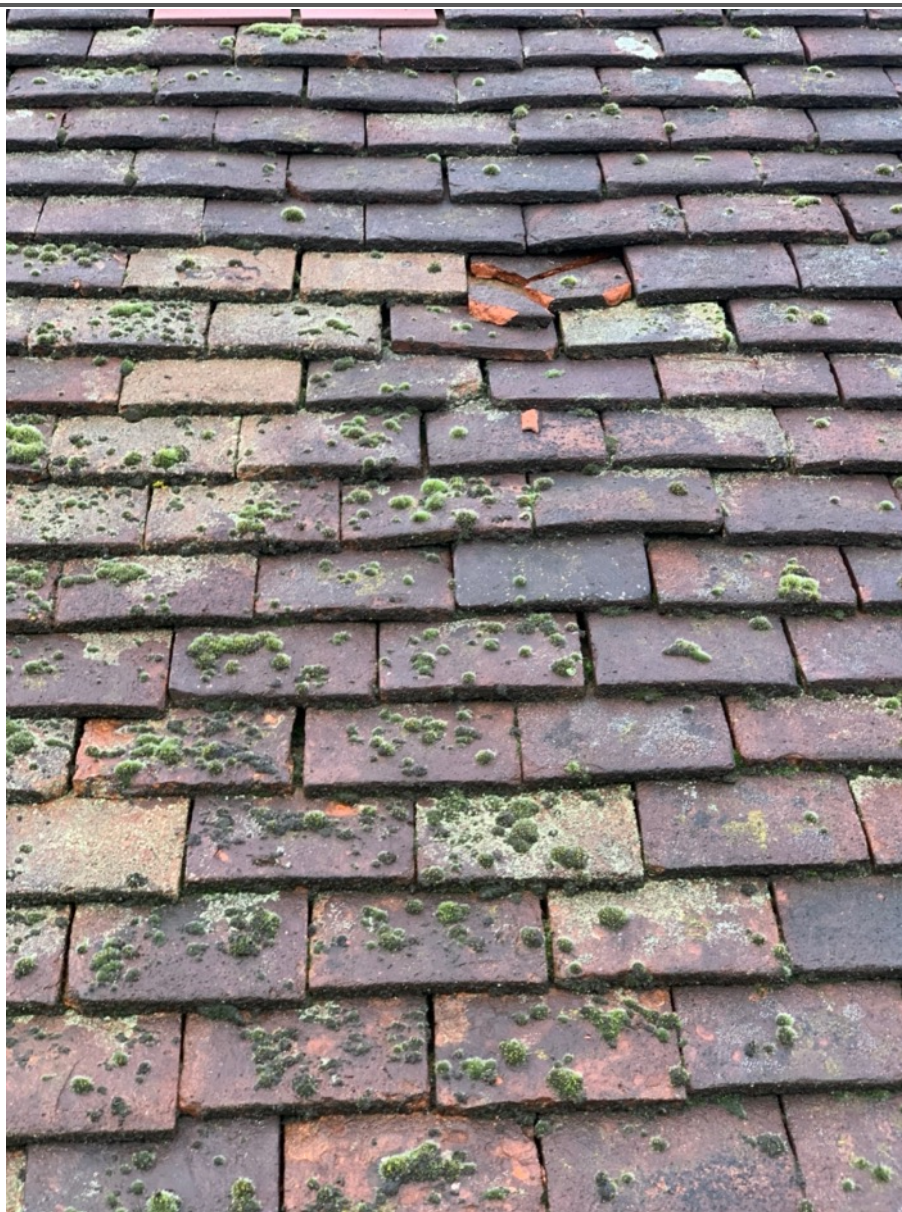
Photo showing impact damage to the roof

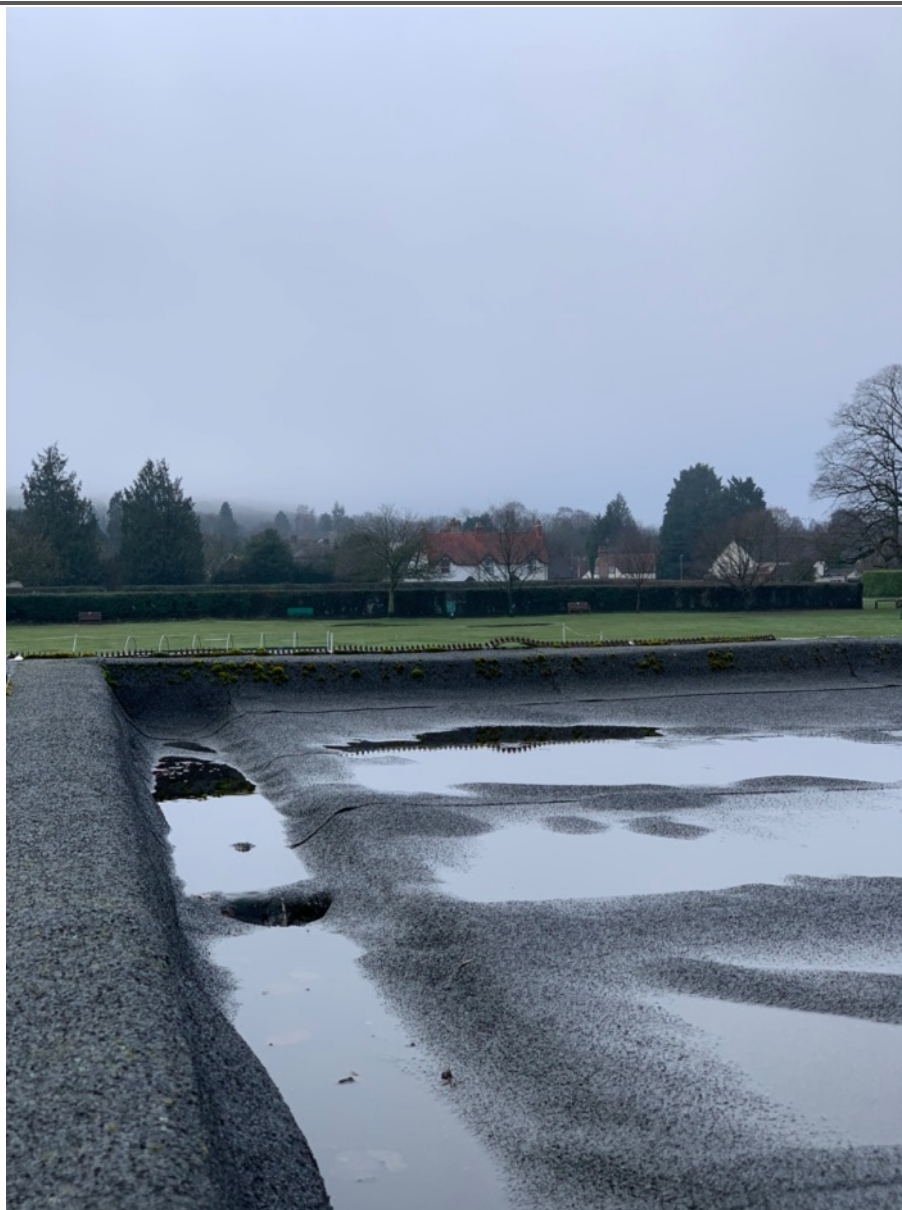
Photo showing ponding water around rainwater gulley indicating failure of water to flow away effectively

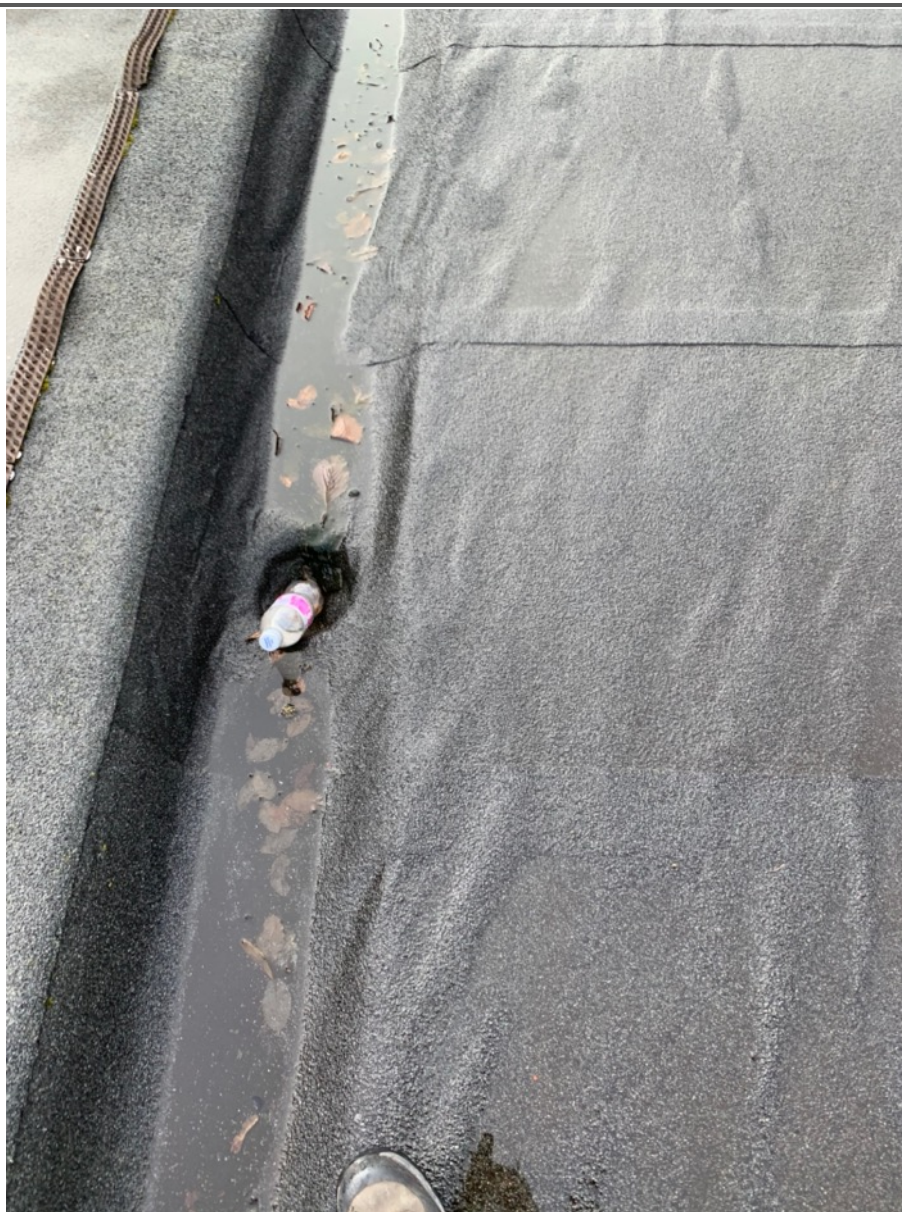
Photo of 1 of 3 bottles inserted into drainage gullies (thought vandalism)

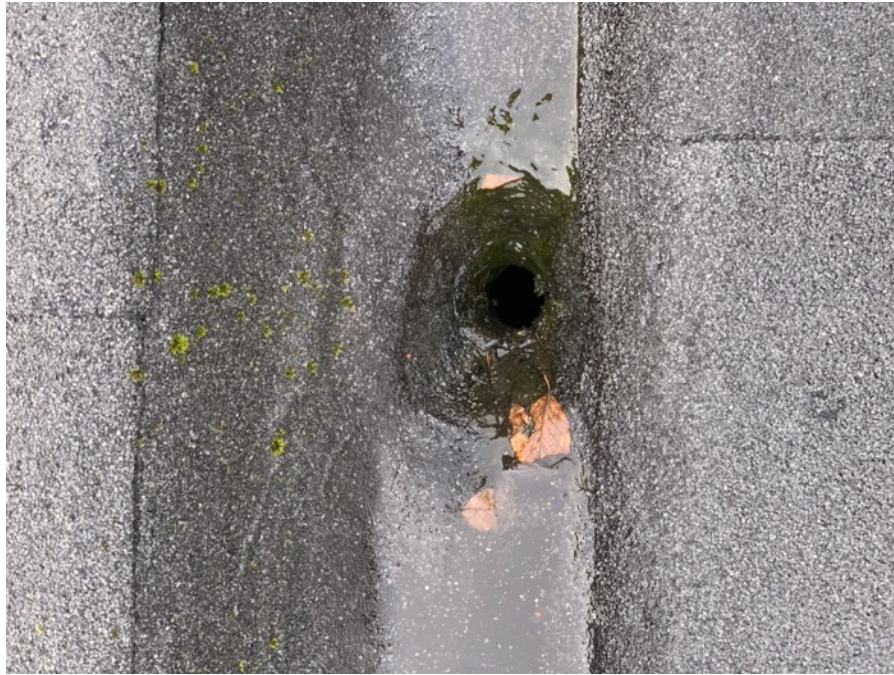
Photo showing that when the bottles are removed,  
the drainage can flow freely.

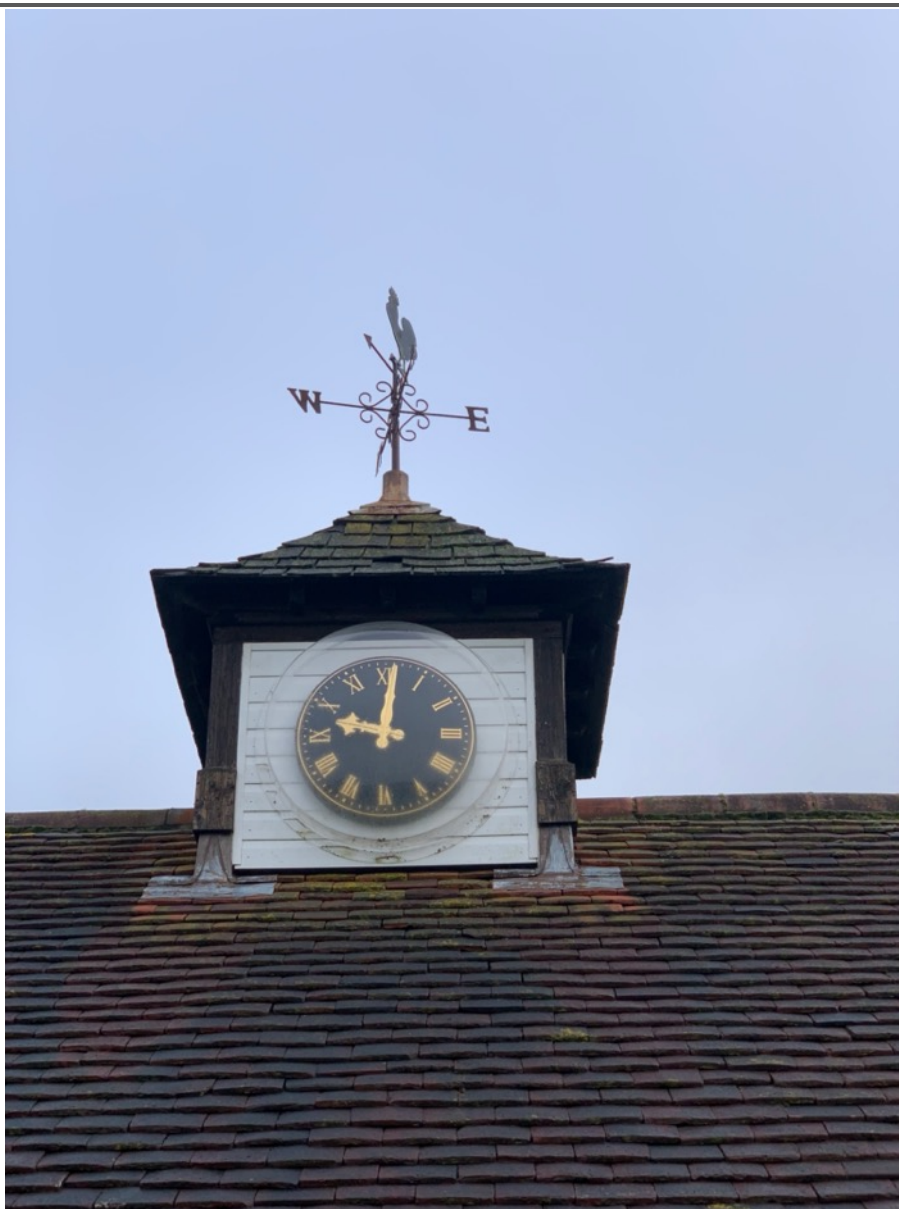
Inset within the roof is the clock tower which we were advised has been recently overhauled to make it operable. Periodic decoration of this is required. No lightning protection to the building found.

Photo showing clock tower

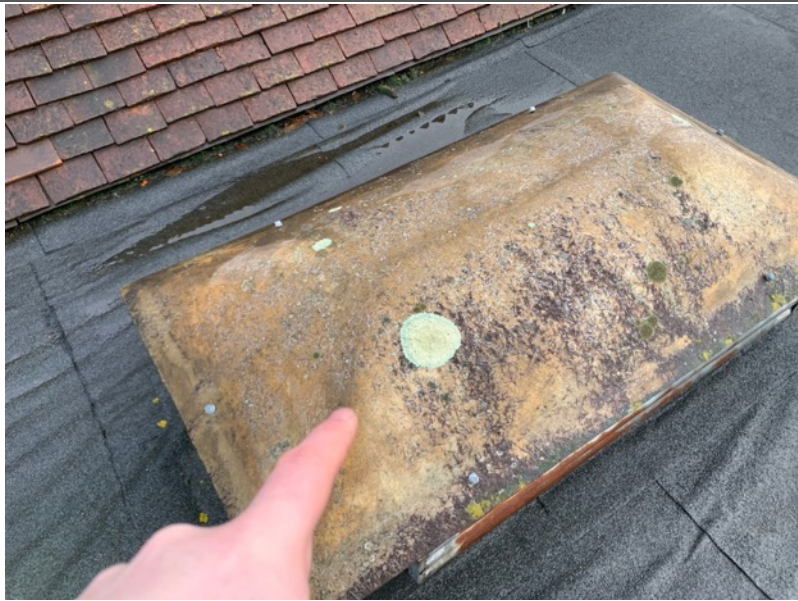
Inset polycarbonate dome rooflights are heavily scorched and discoloured with lichen growth noted ,indicating that the polycarbonate rooflight has become porous. These rooflights would usually be clear. Budget for their replacement.

Photo showing polycarbonate roof dome in poor order

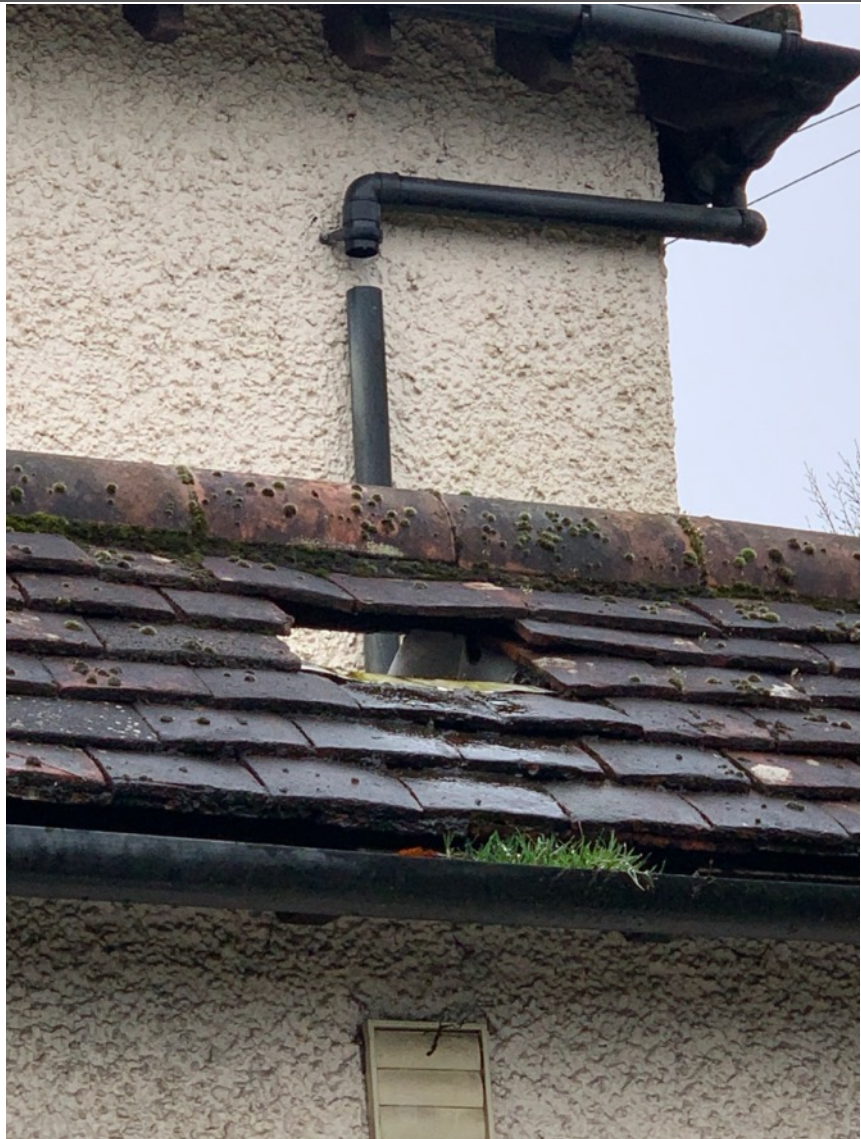
It is evident that the rainwater goods to the property have suffered from some vandalism notably to the front right hand side of the building. These will require repair or replacement.

Photo showing loose vandalised downpipe. Note need to remove grass from gutter,

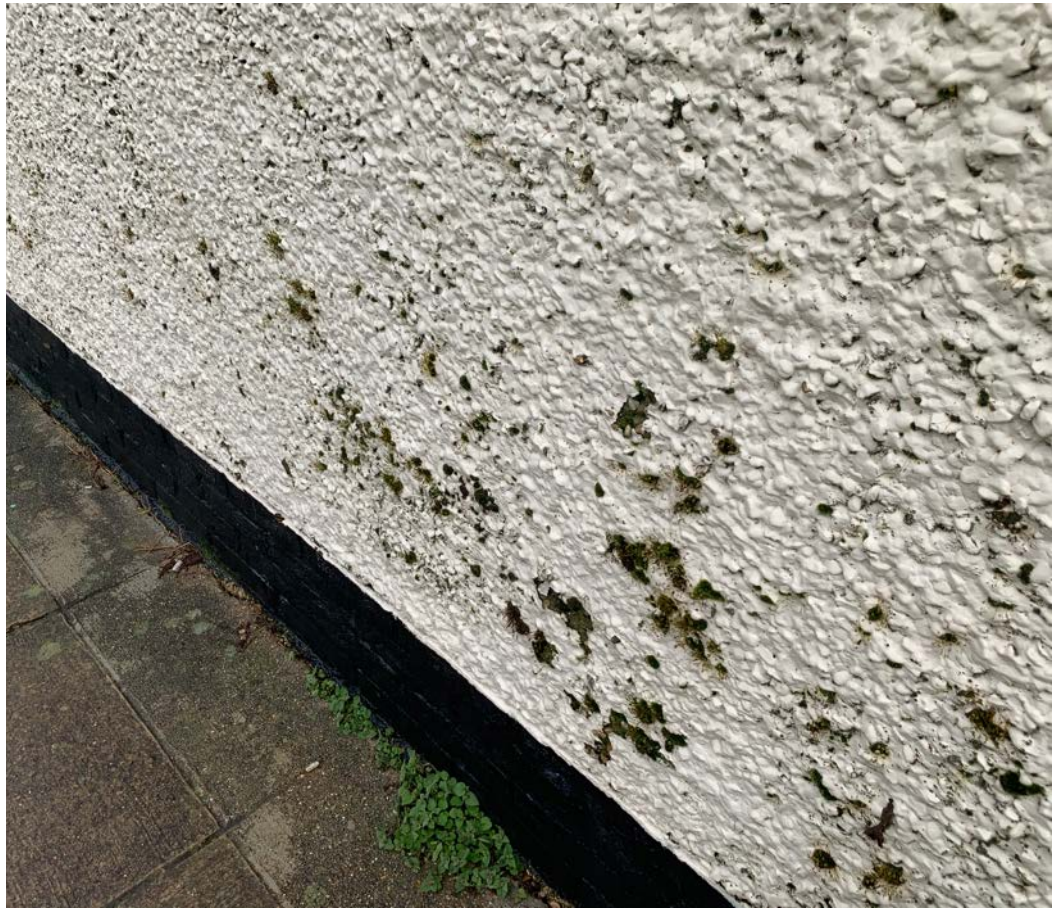
Photo showing porous render

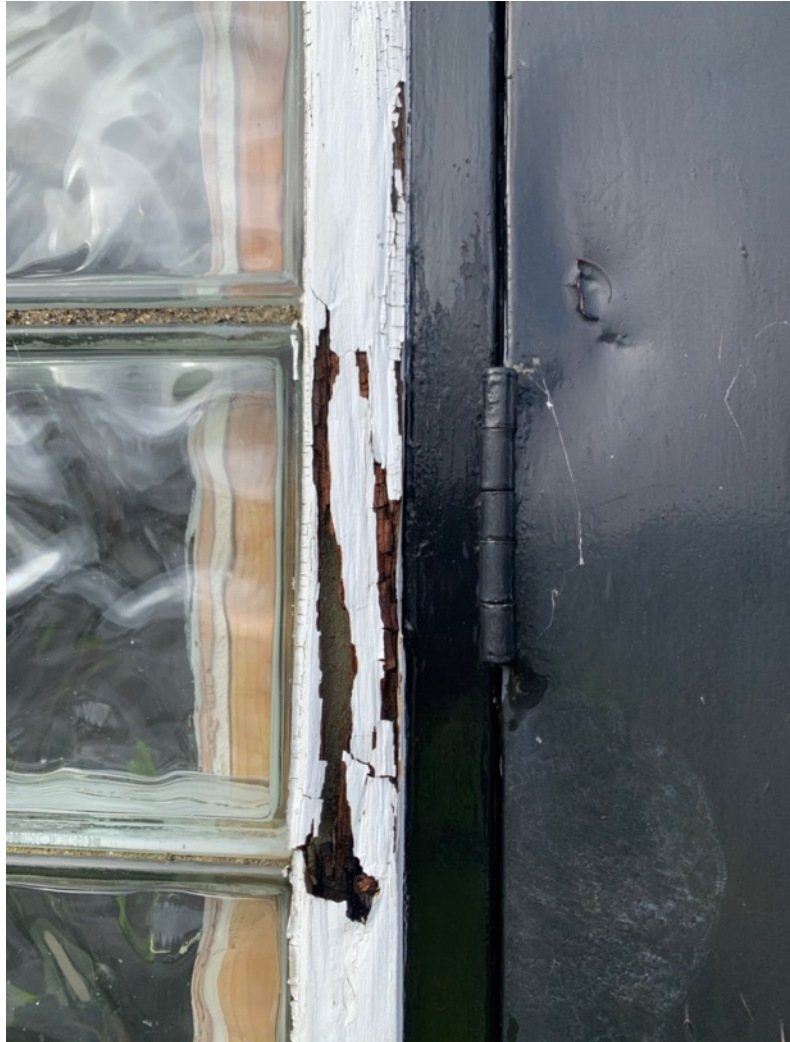
Photo showing window frame to glass brick wall in an advanced state of decay

Windows are a mixture of timber and UPVC. Where timber windows still exist, we would recommend that you budget for their replacement within the next 4 years. Whilst the UPVC frames may be in acceptable order, we would advise that you budget for the replacement of the glazed element again within the next 4 years. The more recently

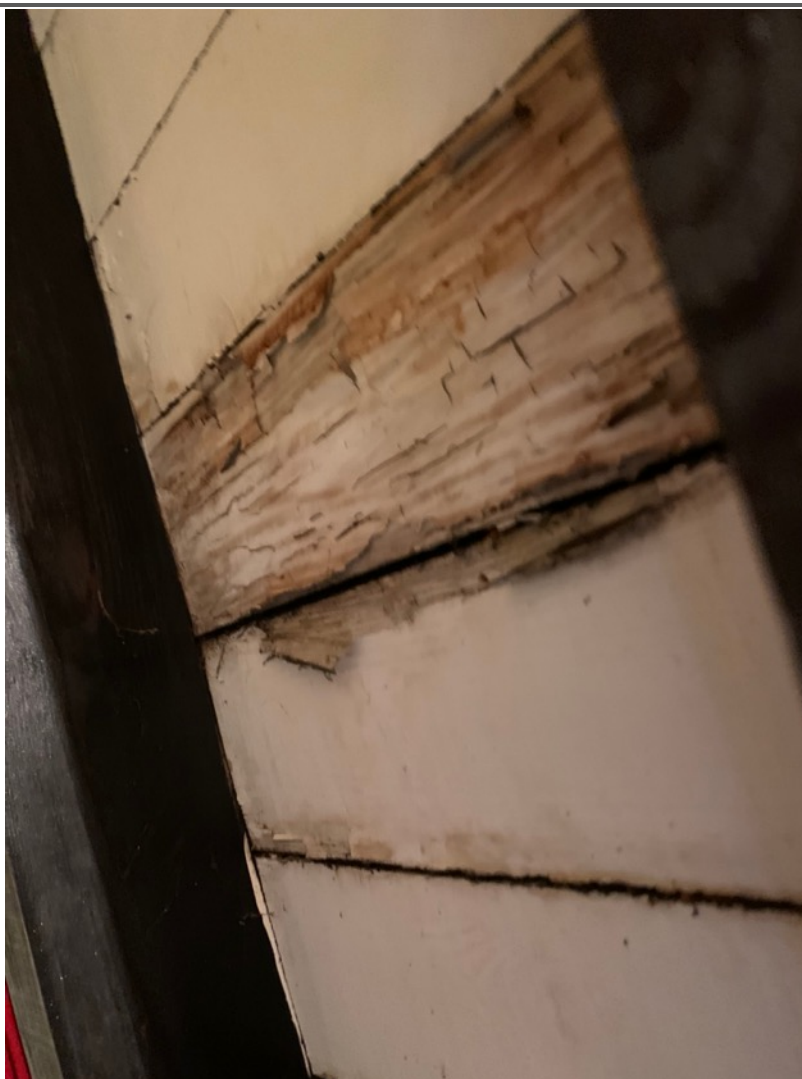
The roof void over the clerks office shows some signs of water ingress are causing decay of the sarking boards.

Photo showing decay of timber sarking board over the clerks office

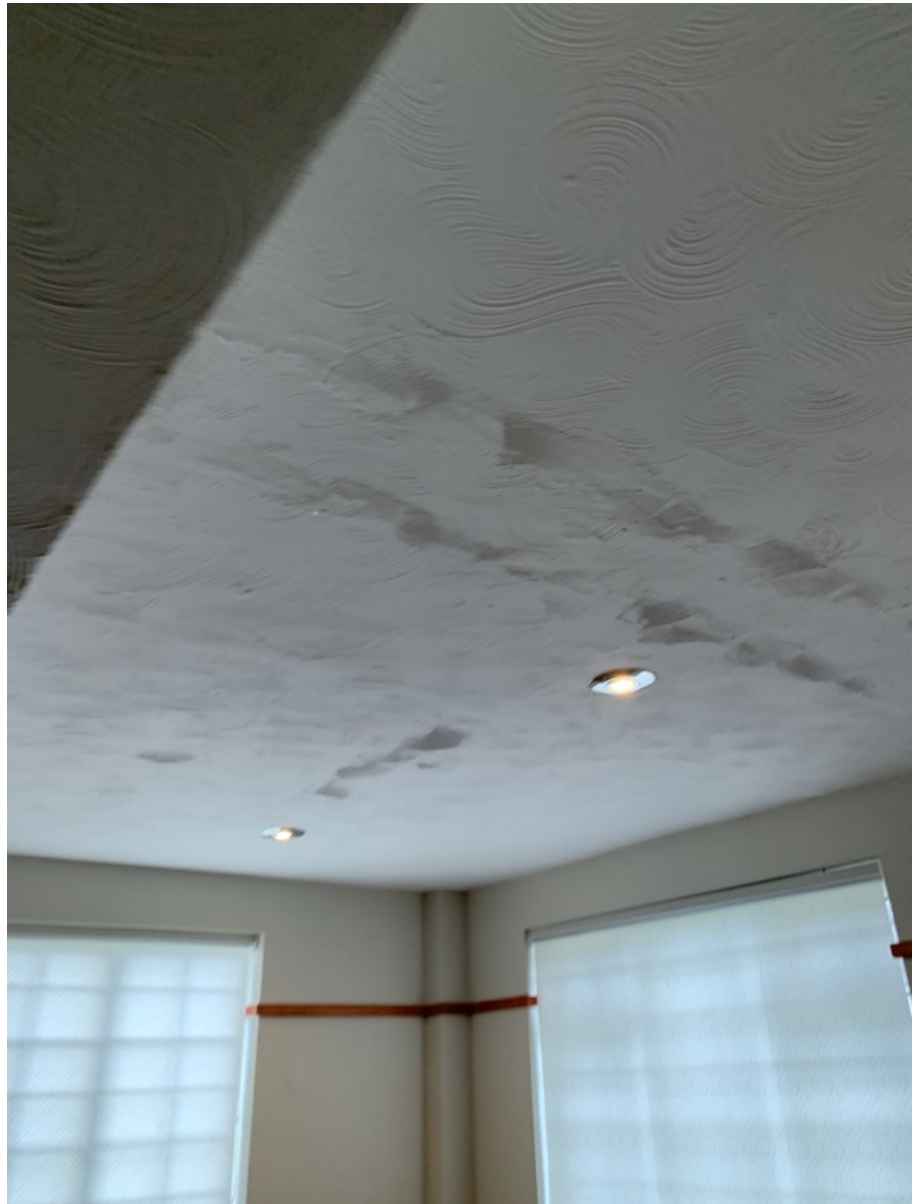
The textured ceiling to the right hand side appears to have suffered some historic water leak thought to have been from the roof above. This issue appear to have been rectified although the ceiling does require replastering and redecoration.

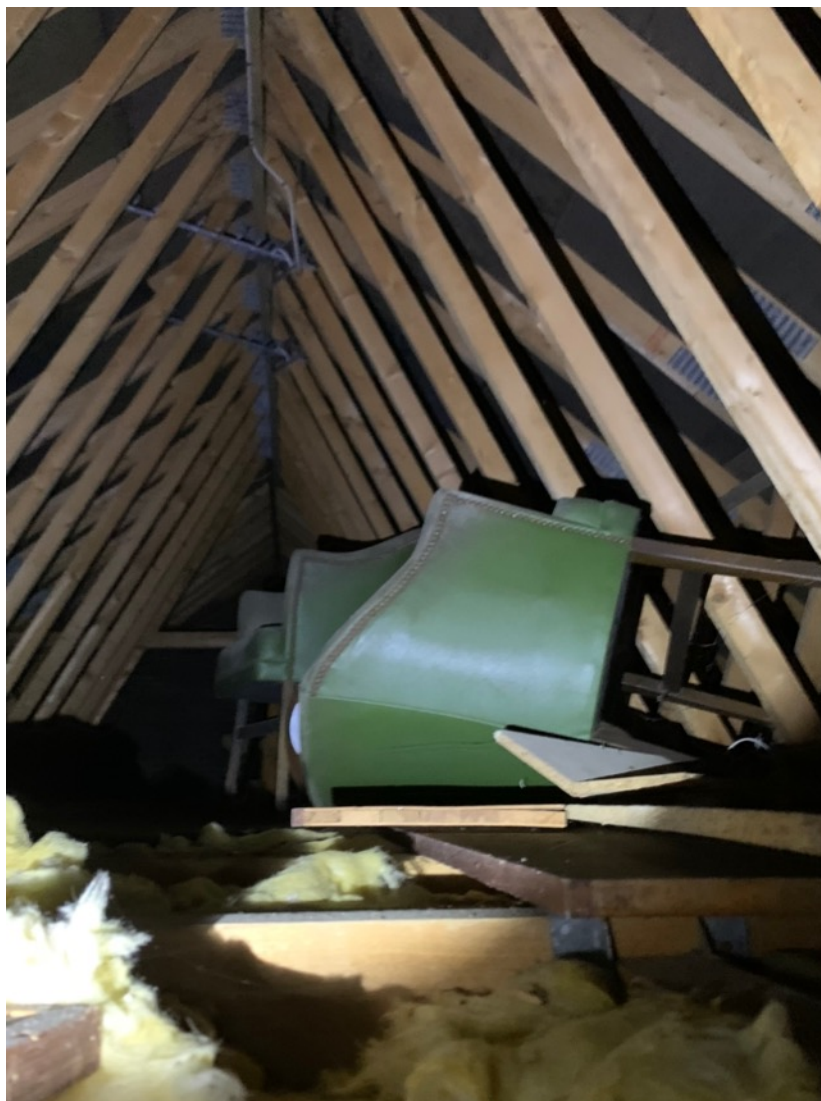
The roof void over the youth club is generally modern is pitched with trusswork. We would comment here that roof insulation would benefit from being improved.

Photo showing roof void
