# Woodcote Village Hall re-roofing works to flat roof sections

The.  
Survey.

Written instructions were received on 18<sup>th</sup> December 2021 from The clerk of Woodcote Parish Council, to carry out a Building inspection on Woodcote Parish Council Offices, Office Village Hall, Reading Road, Woodcote RG8 0QY

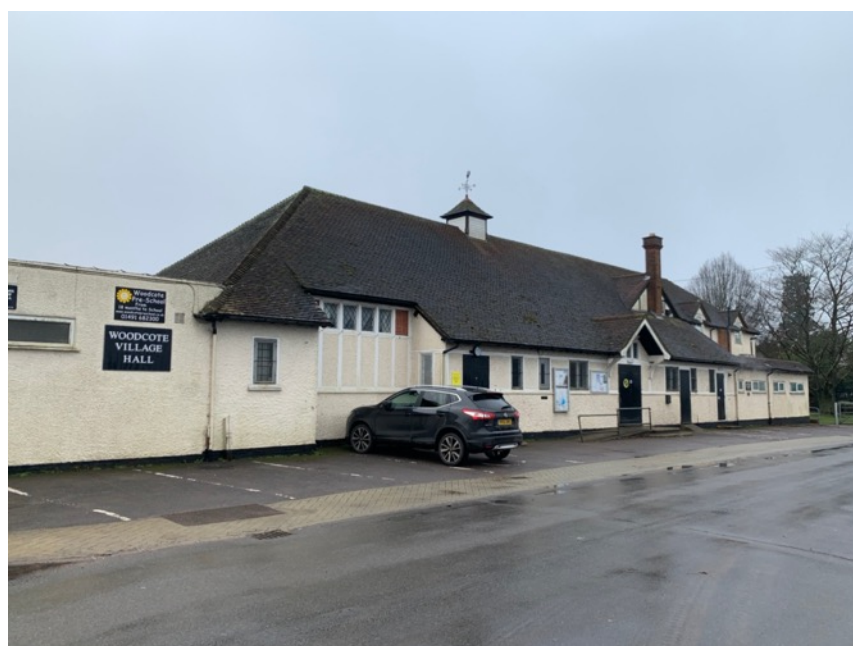
Photo showing front of the property as seen from Reading Road

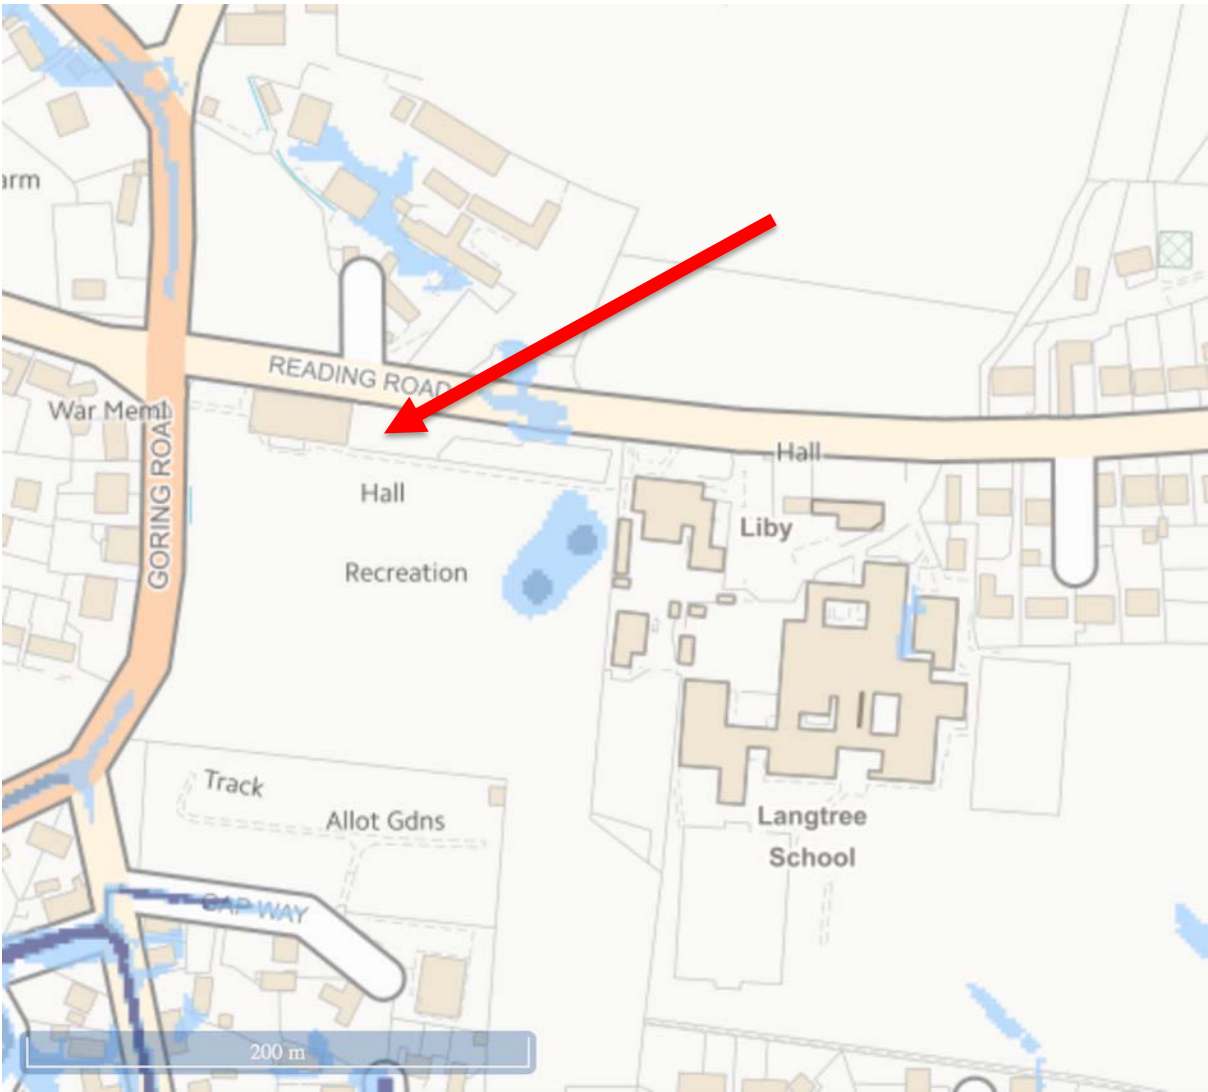
The Building is situated in a largely residential area with very little vehicle traffic noted at the time of our inspection. The property is not thought to be located within a rising water flood plain however there are some signs of minor surface water flooding in the area following rainfall. This is not thought to pose a significant risk to the Parish offices. See Figure 1 Over.

Figure 1 Showing no signs of significant surface water flooding following rainfall

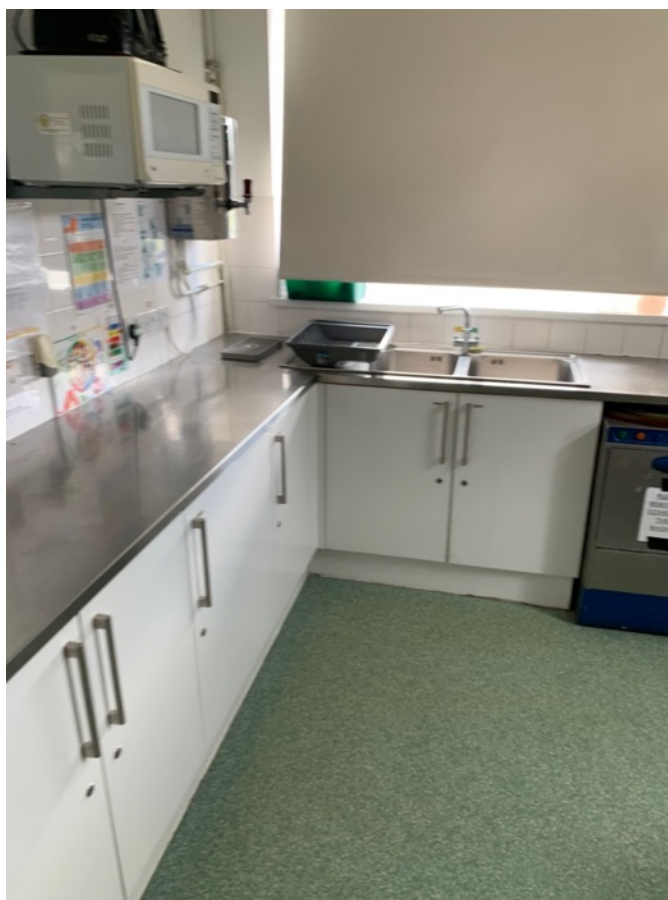
. Fixtures and fittings appear generally clean and usable. Double bowl stainless steel sink was operable at the time of inspection. Sample moisture readings were taken at the base of walls throughout the ground floor accommodation where accessible, without moving any heavy furniture, fixtures or fittings. Our inspection was extremely limited in the kitchen by base cupboards and by appliances. Such restricted moisture meter testing indicated typical low levels of wall plaster dampness thought consistent with a property of this constructional build nature. Readings obtained are thought to generally indicate concealed building courses are currently functional. The separate wall hung water heater in the kitchen was in an acceptable order.

Photo showing Kitchen area

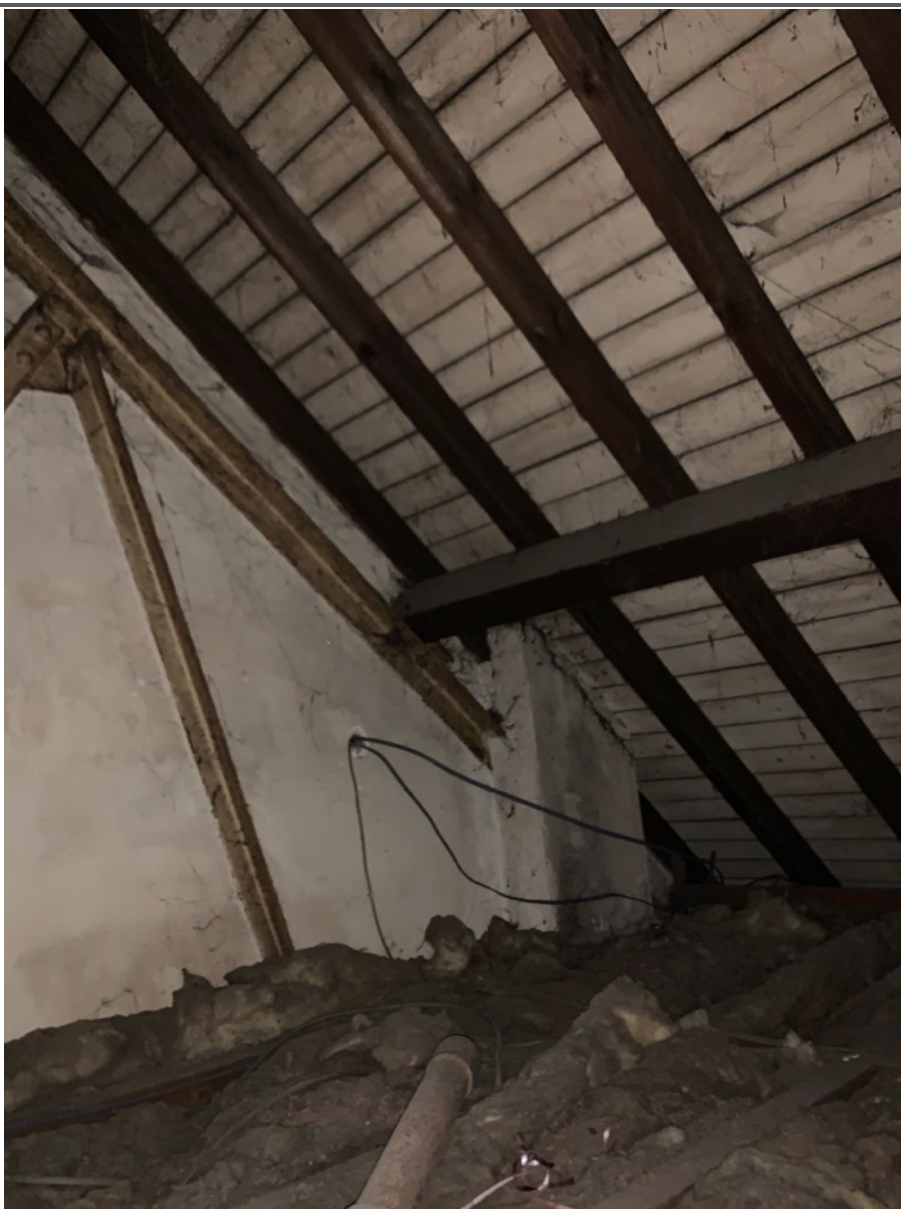
The roof void over the main hall shows some signs of moisture ingress in line with the damage shown externally.

Photo showing steel formwork over the main hall.

It is our recommendation that the roof be repaired, sarking board be cut out and replaced and treatment of the rafters.

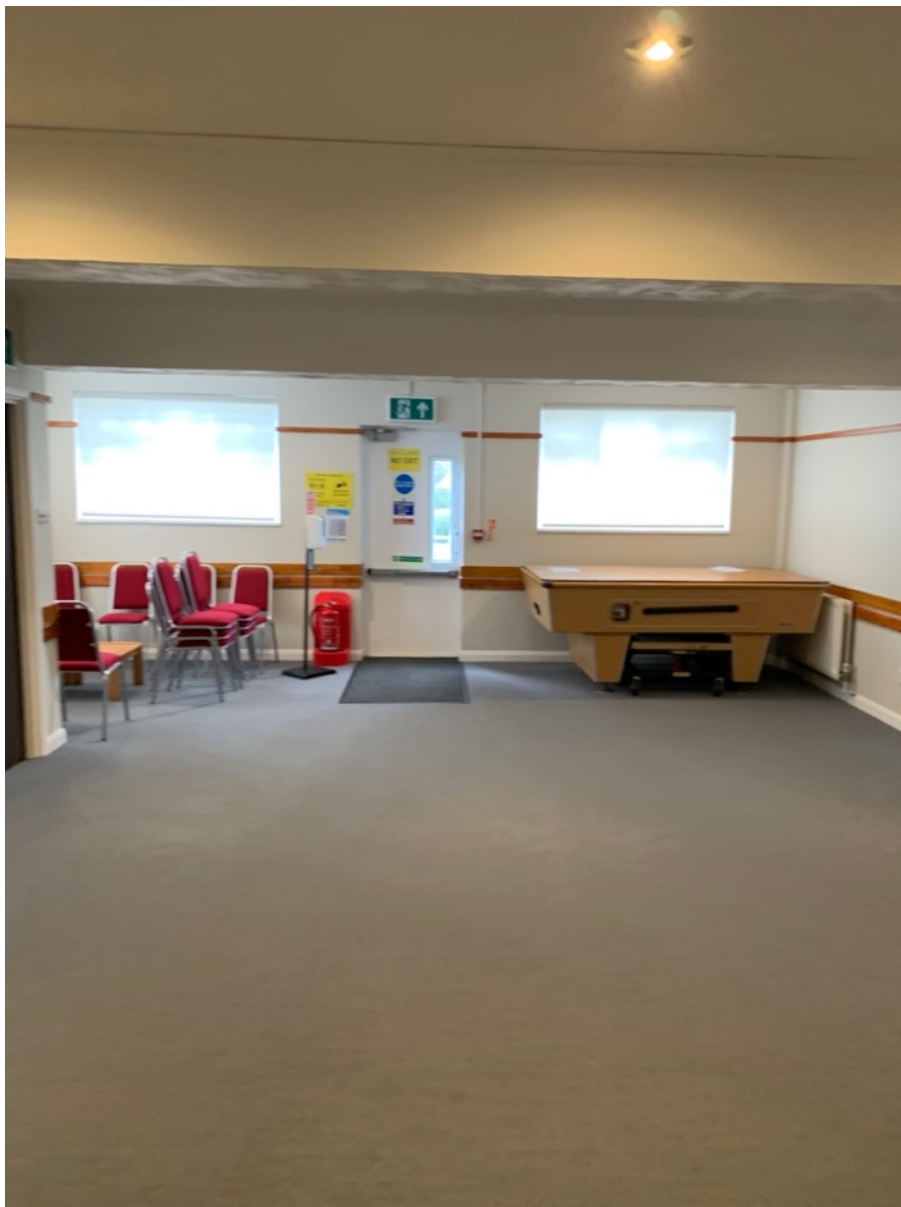
Photo showing fire escape, illuminated signage and fire extinguisher

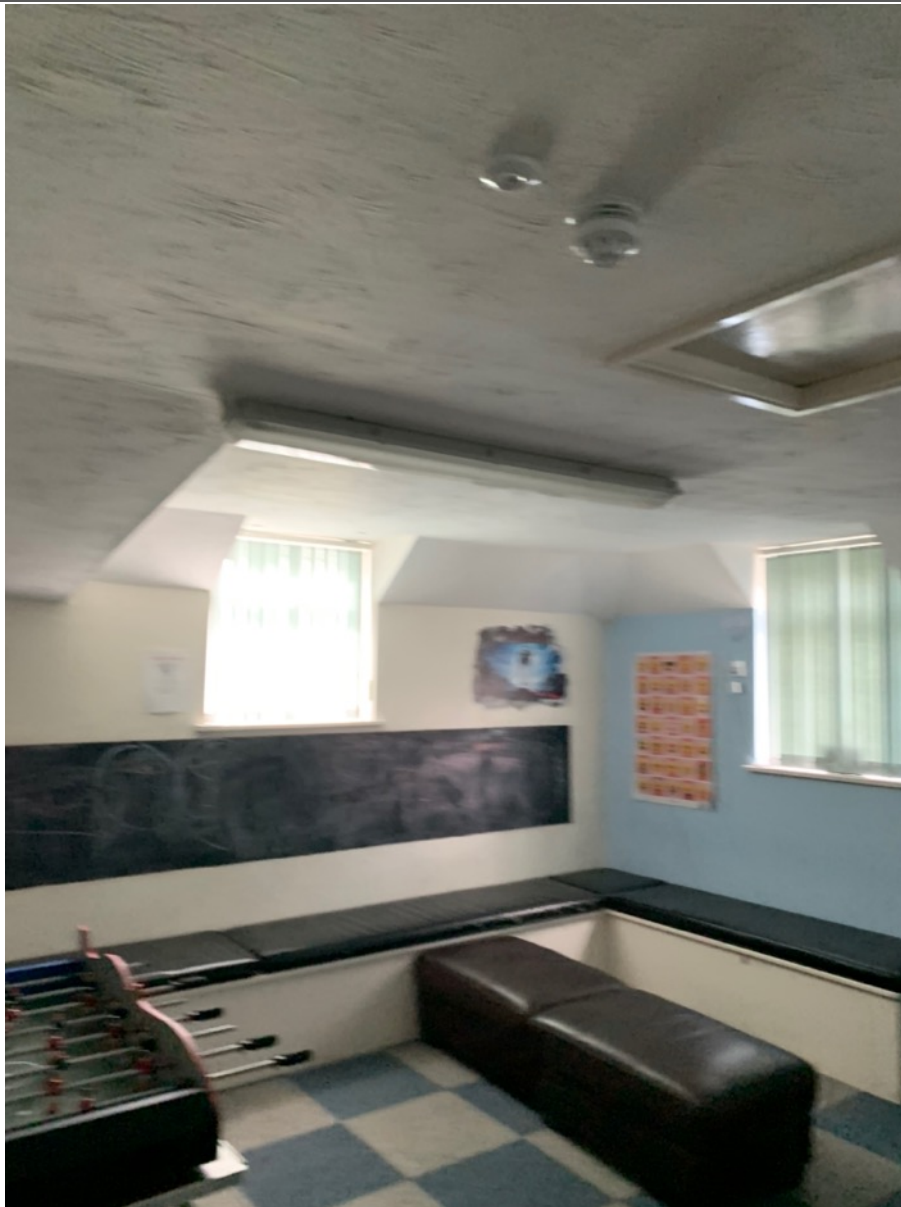
Photo showing textured ceiling coating to the room with inset loft hatch.

The ceiling is painted plaster on plasterboard and again, having been decorated recently, there were no obvious signs of defect noted.
