Woodcote Parish Council

18 July 2025

# Safety Inspection Report

## Annual Inspection

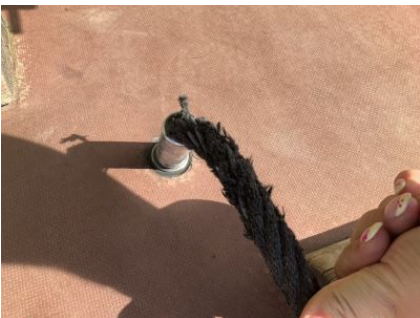
Bolt(s) loose.

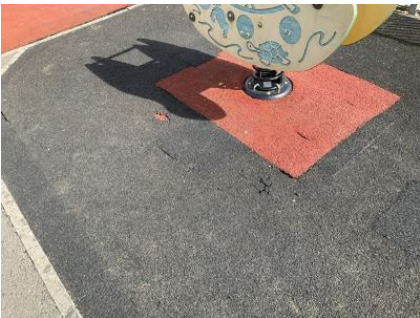
Surface needs repair.

Repair.

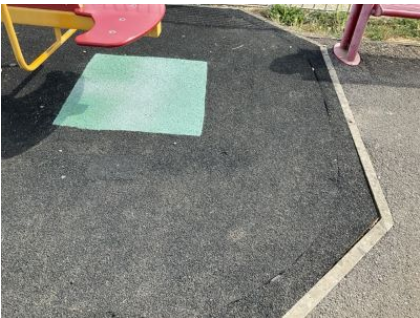
Surface needs repair.

Repair.

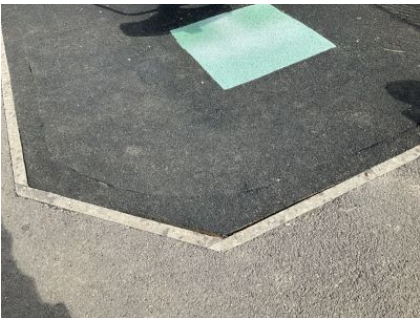
Shrinkage / separation of the surface. This may give a trip hazard.

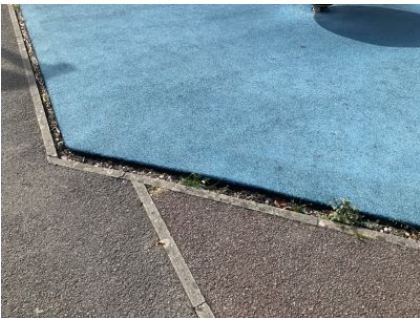
Shrinkage / separation of the surface. This may give a trip hazard.

Repair.

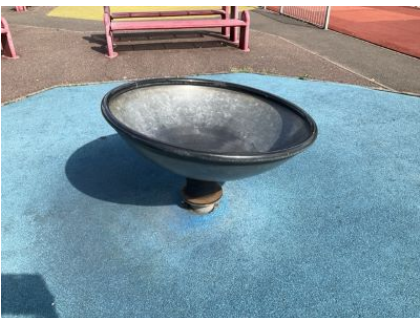
The bearings are worn.

Replace the worn bearings.

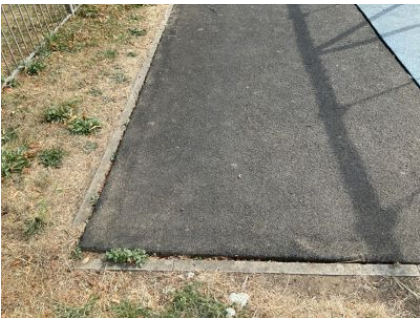
Shrinkage / separation of the surface. This may give a trip hazard.

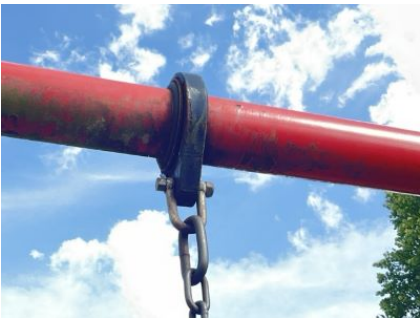
Item has corrosion.

Treat and repair.

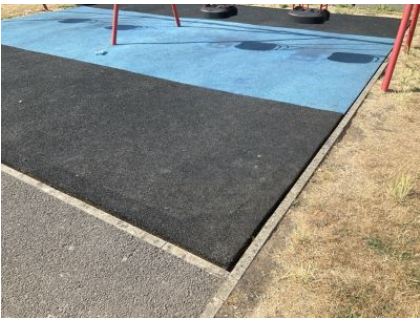
Shrinkage / separation of the surface. This may give a trip hazard.

Repair.

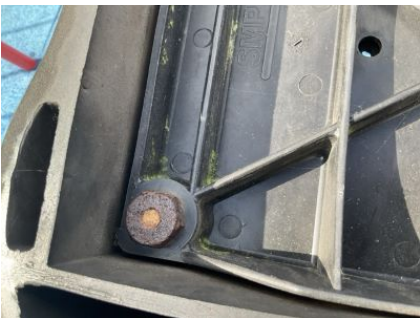
Fittings are rusty.

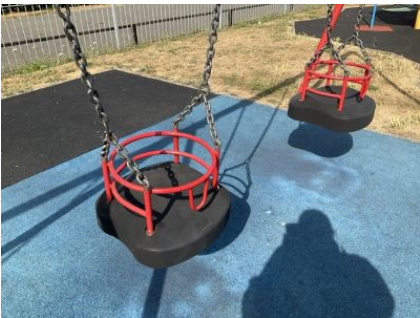
Item has corrosion.

Treat and repair.
